Battery Cell Leak Testing

Multiple testing methods are herein presented to quantitatively, deterministically and non-destructively leak test prismatic or cylindrical lithium-ion battery cells. **At this time no test method has been codified for finding small leak channels in the battery cells.** While the minimum detection limit of the available test methods has yet to be determined, the methods detailed in this paper have been demonstrated to effectively find leaks that are common in automated cell manufacturing lines. **The nature, cause and approximate size of the defects are described in this paper along with the methods shown to be effective in testing for them.**

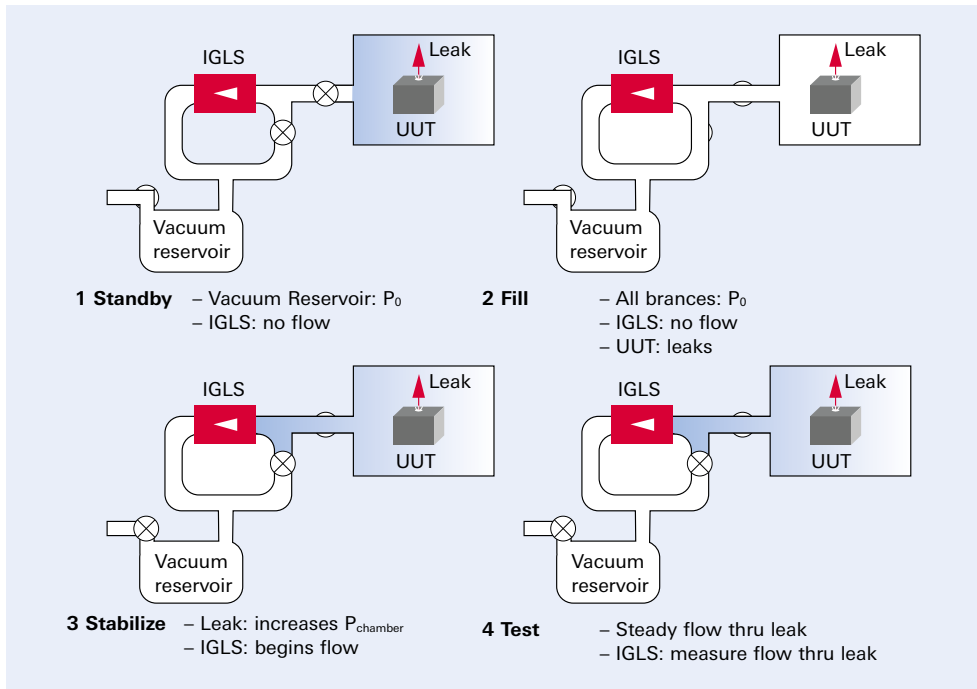
Figure 1: Mass Extraction Diagram

Mass Extraction- The preliminary leak test is a mass extraction test using a Pfeiffer Vacuum ME4 mass extraction instrument. Mass extraction utilizes a vacuum pump to evacuate a chamber containing the test article, and measures the flow rate from the chamber to a vacuum reservoir. Flow rates can be correlated to determine the size of the defect in the unit under test. In this study, the flow values from the bad samples very quickly exceeded the full scale of the sensor, so no correlation was possible.

The initial test was a measurement of the control negative samples. The mass extraction test of the control samples showed an average background flow measurement of 16.7 micrograms per minute. A retest of the same samples with a 5-micron calibrated leak added to the test yielded an average of 42.0 micrograms per minute of flow. These were the results of the fine leak measurement at the end of a 40 second test. The control positives that were manufactured with the tab and seal defects all either failed the gross leak check or very quickly went to the full scale of the sensor and the tests were ended in 15 seconds.

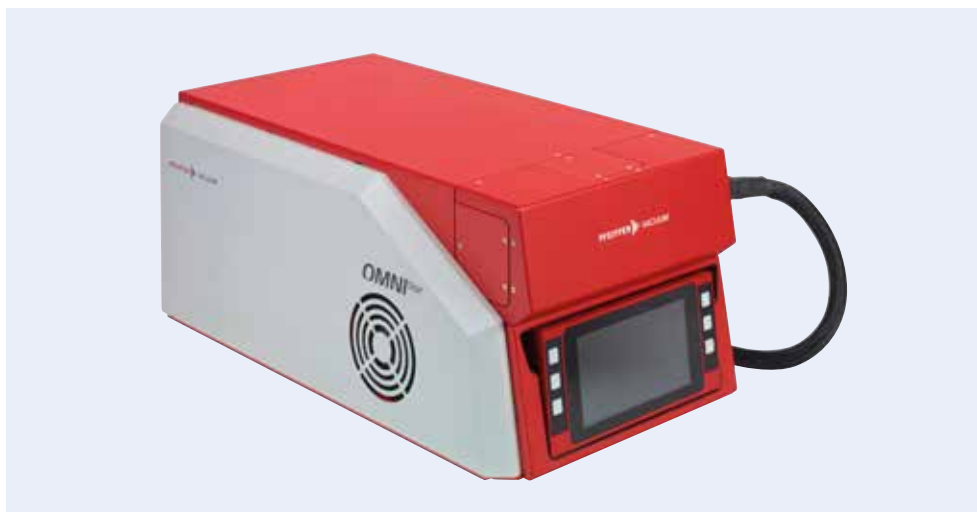
Figure 2: Omnistar

The OmniStar is a self-contained gas analysis system able to measure gasses and vapors up to 300 amu. This compact mass spectrometer-based analyzer includes a 1 or 2 meter heated sampling probe to enable gas analysis from atmospheric pressure down to 10 Torr. Results are available in real-time with continuous measurement speeds in the sub 1 second range.

The Omnistar background measurement of the control negatives averaged an ion current of $4.8 \cdot 10^{-12}$ A of the 59 AMU signal, corresponding to a constituent of the electrolyte solvent 30 seconds after the conclusion of the mass extraction test, and $3.6 \cdot 10^{-11}$ A immediately after the vacuum in the test chamber was purged. The control positives with the bad tabs averaged $8.2 \cdot 10^{-10}$ A 30 seconds after the conclusion of the Mass Extraction test and $6.8 \cdot 10^{-8}$ A immediately after purging the vacuum. The control positives with the bad seals averaged $7.5 \cdot 10^{-10}$ A 30 seconds after the conclusion of the mass extraction test and $5.5 \cdot 10^{-8}$ A immediately after purging the vacuum chamber.

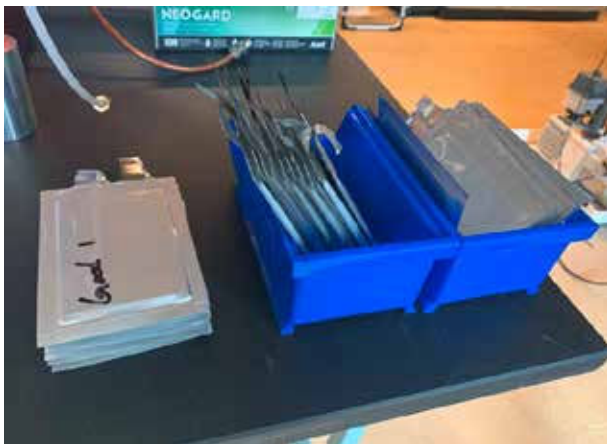
Figure 4: Test Samples: Good, Bad Tabs, Bad Seals

For the leak testing experiment, a series of 30 pouch cells were made; ten were made without deliberate flaws, ten were made with bad tab seals, and ten were made with incomplete side seals. The cells (72 x 110 x 2.5 mm, approximately 3.5 Ah) were representative of current state of the art pouch cells, manufactured in a Z-fold stack with 8 NMC 111 cathode layers and 9 graphite anode layers, separated with Entek EPH 16 μm polyethylene separator film. The electrodes were stock electrodes coated and calendered on roll-to-roll processing machines. As the cells were not intended for cycling, the electrode loadings were not precisely balanced.

The “good” cells were made with no purposefully introduced defects during the tab welding or bag sealing steps. The “bad tab seal” cells were made to represent a cell in which the ultrasonically welded, 15 mm x 0.1 mm extension tab is misaligned with the heat-sealed bag edge, causing an incomplete or missing seal around the tabs. This was achieved by loading the tabs into the ultra-sonic welder in reverse so that the thermoplastic strip (which assures a good seal between the tab and the pouch) was outside of the heat-seal area. A seal can be achieved between the pouch material and the tab directly, but is much more prone to leaks than a seal that has been made between the pouch and the thermoplastic strip.

The “bad side seal” cells were made by placing an 8 mm x 0.1 mm aluminum shim between the layers of the pouch material during heat sealing, which was subsequently removed, leaving an \sim 8mm unsealed area along the side seal. This defect was made to simulate a failing heater cartridge in the sealing machine which may result in a partial complete seal, with partial open areas.

The cells were filled with an electrolyte solution of 1M LiPF₆ in 1:1 ethylene carbonate: ethyl, methyl carbonate from Soulbrain USA. The ten good cells and ten bad tab seal cells were filled with 10 g of electrolyte solution each, the bad side seal cells were filled with 7.5 g of electrolyte solution each, before vacuum and final sealing operations. The trimmed cells were leak checked prior to any sort of tap charge, or formation cycling.

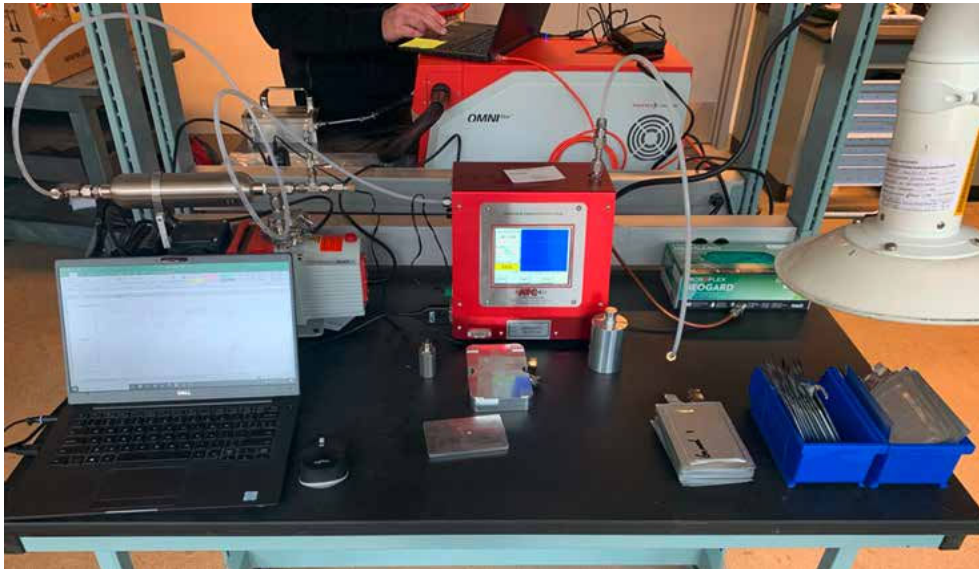
Figure 7: Test Apparatus

1. Place cell in test chamber
2. Evacuate test chamber for 15 seconds
3. Dwell 30 seconds after evacuation ends
4. Record sniffer measurement
5. Purge vacuum
6. Record sniffer measurement

- Sniffing bad cells at barometric condition did not detect the presence of electrolyte in known leaking samples.
- Placing the cells inside a chamber and evacuating causes the electrolyte to evaporate and leave the cell through the defect.
- This evaporated electrolyte was then detectable with the instruments described above.
